# Premier Water Case Study: Residential Iron Filtration System in Deephaven, MN

October 2009

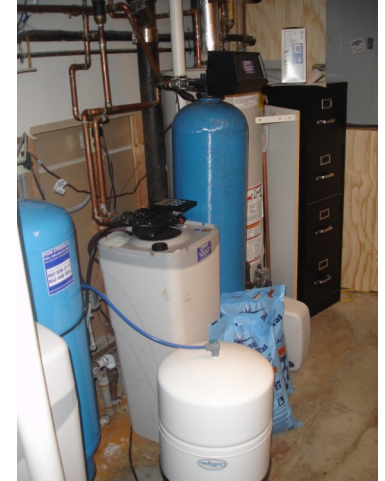
**Old System**

The existing 10" x 47" iron filter was in bad shape, and had been partially disabled by other sub contractors over the years. At the homeowner's request, we re-built the head and added a new air relief valve to try and get this system to "limp along".

By October, 2009 the old iron filter was failing again. The rust stains and rotten egg smell were starting to take it's toll on the plumbing, water softener AND the homeowner. They were ready for a real iron system:

## Why the Previous Iron Filter System Failed:

- Inadequate Iron and Hydrogen sulfide capacity
- Iron and Hydrogen Sulfide were not completely oxidized
- Undersized filter vessel did not support the water flow rates of this family
- Iron-clogged plumbing reduced the filter's backwash ability (clean itself)
- Frequent power outages constantly disrupted the filter's settings

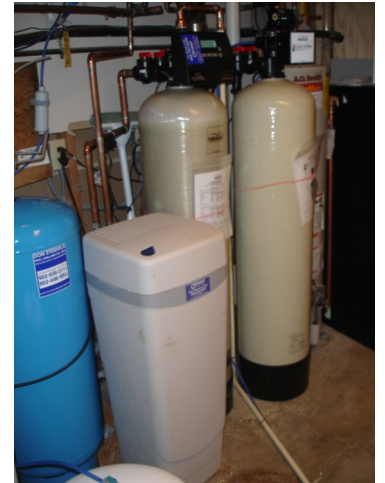
**New System**

The new system completely eliminated the rust stains and odor problems, the softener now works more efficiently, and waste water was reduced. The results speak for themselves:

Water Quality BEFORE	Water Quality AFTER
Hardness: 30gpg Total Iron: 6ppm	Hardness: 0gpg Total Iron: 0ppm

The old ¾" copper was replaced with new 1" copper for less restriction and improved backwashing (cleaning) ability. A 13"x54" dedicated aeration tank was used to pre-treat the water and oxidize the iron and hydrogen sulfide for better filtration. A 13"x54" vessel using vertical depth filtration replaced the small 10" filter to meet the needs of this family's heavy water use.

A special distributor was also used to reduce waste water by 30% over the old system. A digital controller runs the system and holds all settings up to 2 ½ years during power loss to combat the frequent power outages here.
