Case Study: Residential Iron Filtration System in Deephaven, MN

October 2009

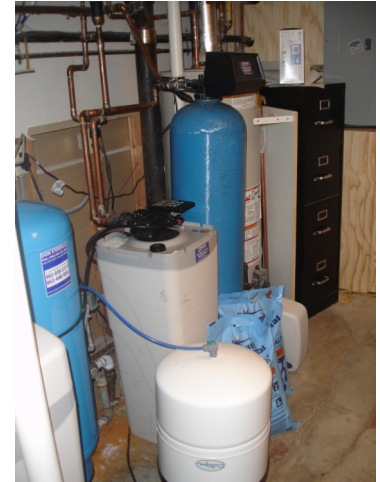
Old Iron Filter

The existing 10" x 47" iron filter was in bad shape, and had been partially disabled by other sub contractors over the years. At the homeowner's request, we re-built the head and added a new air relief valve to try and get this system to "limp along".

By October, 2009 the old iron filter was failing again. The rust stains and rotten egg smell were starting to take it's toll on the plumbing, water softener AND the homeowner. It was time for a real iron filter system:

- Inadequate Iron and Hydrogen sulfide capacity
- Iron and Hydrogen Sulfide were not completely oxidized
- Undersized filter vessel only provided 2.7gpm flow (enough for 1 faucet)
- Iron-clogged plumbing reduced the filter's backwash ability (clean itself)
- Frequent power outages constantly disrupted the filter's settings

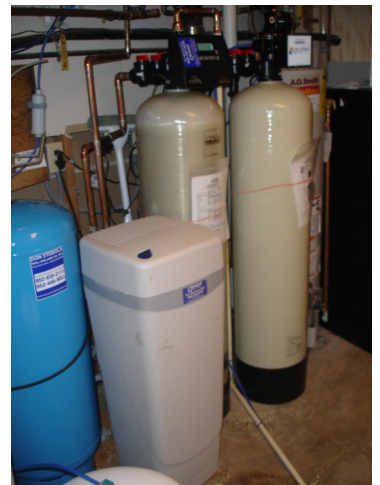
New Iron Filter System

The old ¾" copper was replaced with new 1" copper for less restriction and improved backwashing (cleaning) ability. A 13"x54" dedicated aeration tank was used to pre-treat the water and oxidize the iron and hydrogen sulfide for better filtration. A 13"x54" vessel using vertical depth filtration replaced the small 10" filter to handle heavier water flow rate needs up to 8gpm.

A special distributor was also used to reduce waste water by 30% over the old system. A digital controller runs the system and holds all settings up to 2 ½ years during power loss to combat the frequent power outages here.

The new system completely eliminated the rust stains and odor problems, the softener now works more efficiently, and waste water was reduced. The results speak for themselves:
